Use Attainability Analysis

WBID 0833 Linn Creek

Submitted by
SES, Inc.

To
Missouri Department of Natural Resources
Water Protection Program

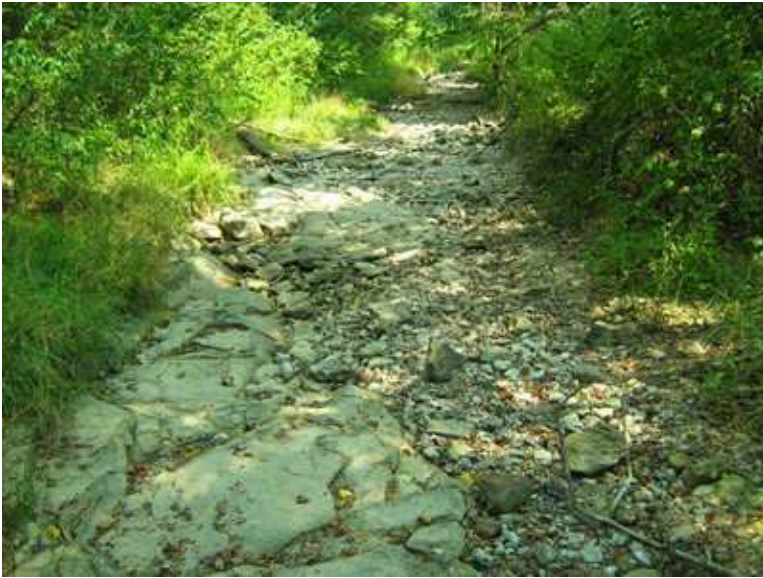
Site# 1 Photo ID# 14, Upstream

WBID # 833 **Site #** 1
Mark # 13 **Dissolved Oxygen (ppm)** N/A
Upstream Views Physical Dimensions: Is there any water present at this view? no

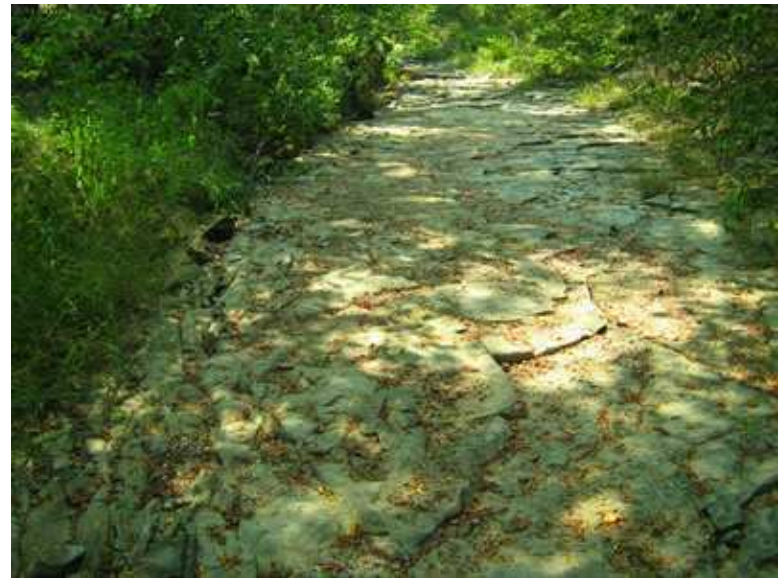
Site# 1 Photo ID# 15, Downstream

Downstream View's Physical Dimensions: Is there any water present at this view? no

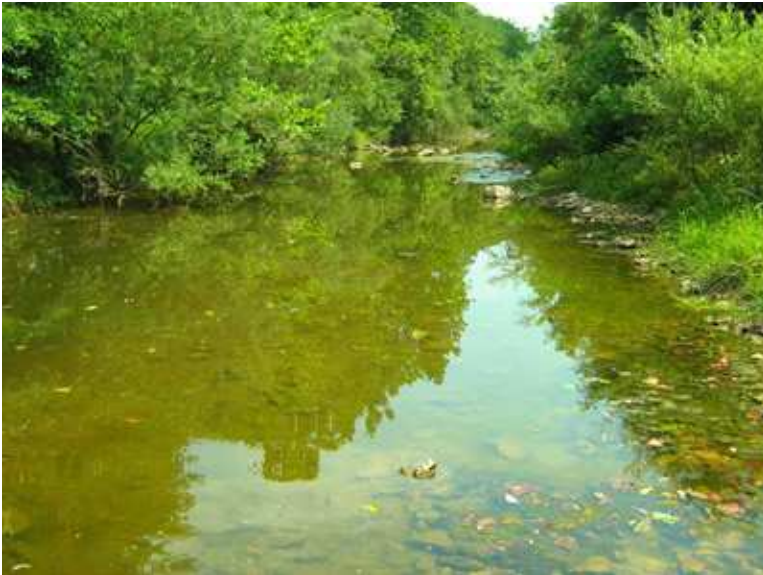
Site#2 Photo ID# 17, Upstream

WBID # 833 **Site #** 2
Mark # 14 **Dissolved Oxygen (ppm)** 12.4
Upstream Views Physical Dimensions: Is there any water present at this view? yes

If so, is there an obvious current? no

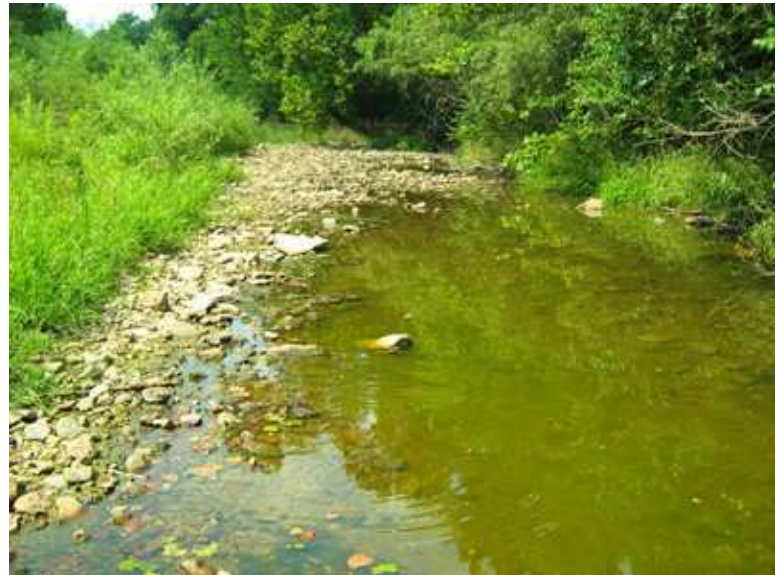
Site# 2 Photo ID# 16, Downstream

Downstream View's Physical Dimensions: Is there any water present at this view? yes

If so, is there an obvious current? no

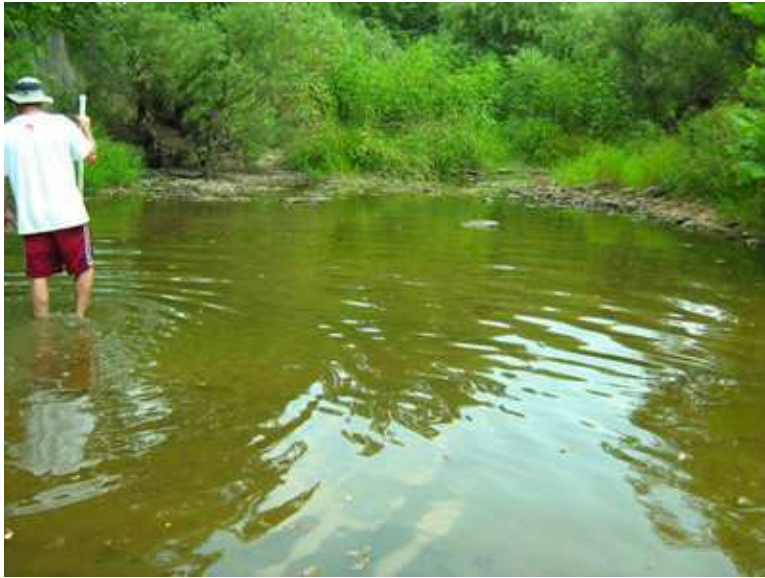
Site# 3 Photo ID# 19, Upstream

WBID # 833 **Site #** 3
Mark # 15 **Dissolved Oxygen (ppm)** 10.4
Upstream Views Physical Dimensions: Is there any water present at this view? yes
 If so, is there an obvious current? no

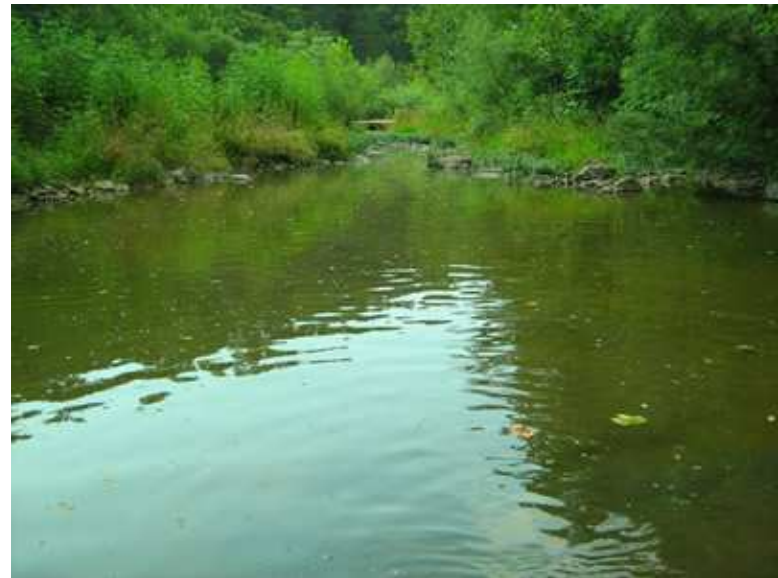
Site# 3 Photo ID# 18, Downstream

Downstream View's Physical Dimensions: Is there any water present at this view? yes
 If so, is there an obvious current? no

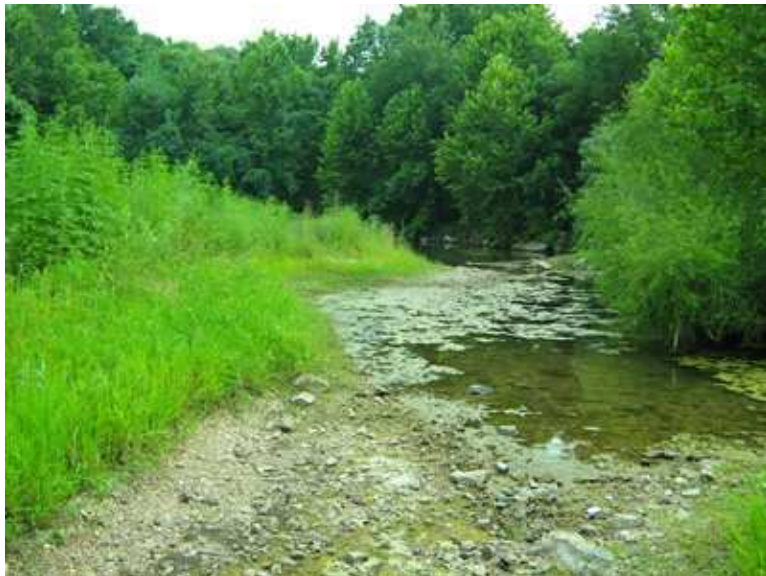
Site#4 Photo ID# 21, Upstream

WBID # 833 **Site #** 4
Mark # 16 **Dissolved Oxygen (ppm)** 10.1
Upstream Views Physical Dimensions: Is there any water present at this view? yes

If so, is there an obvious current? no

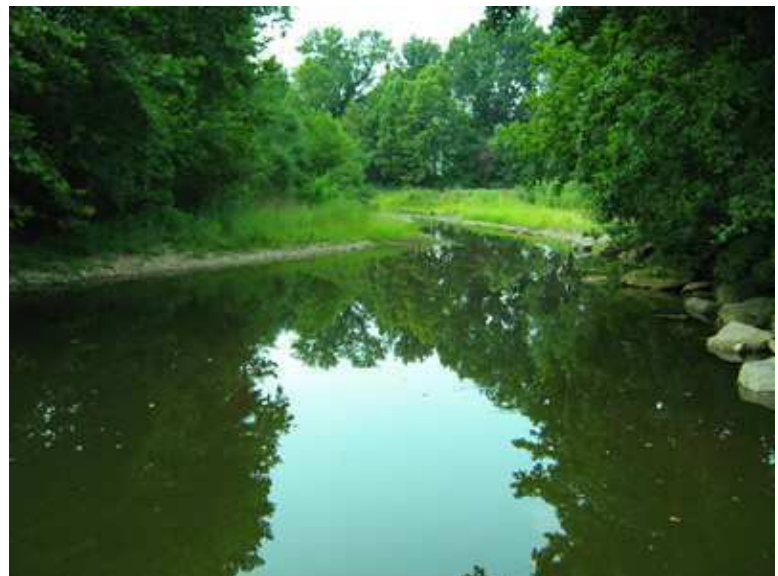
Site# 4 Photo ID# 20, Downstream

Downstream View's Physical Dimensions: Is there any water present at this view? yes

If so, is there an obvious current? no
